Electronic Servicing

Special TV repair issue

**GE video
MATV noise
Narrow picture
Missing sync**

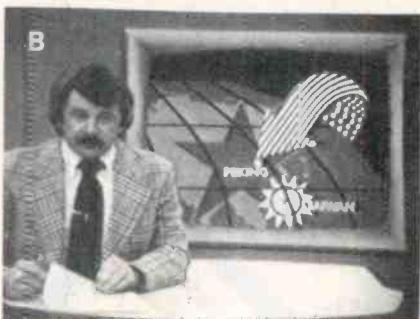
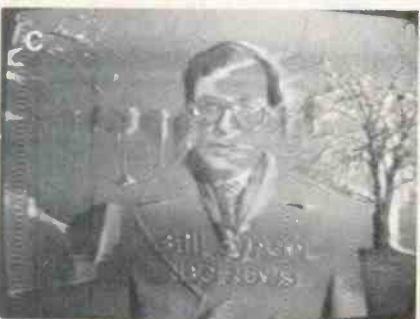
Figure 8 A serious picture degradation occurs when diode Y220 shorts. In A, the top trace is the normal generator video at the Y220 anode. Lower trace shows the distortion caused by a shorted Y220. TV picture B is a normal one, while picture C shows the same TV picture after Y220 was shorted. There is a compression of most shades of brightness plus a trailing smear and the picture was much darker.

A severe degradation of picture quality occurs when diode Y220 is shorted, in addition to the large reduction of brightness. In this case, L220 is the only load for the signal coming through C220, so overpeaking and waveform distortion occurs. Figure 8 shows a waveform and a TV picture for normal operation plus (for comparison) another waveform and TV picture when Y220 was shorted. The TV picture when the diode was shorted is difficult to describe. One of the effects resembles white compression. But another shows smears along the trailing edges.

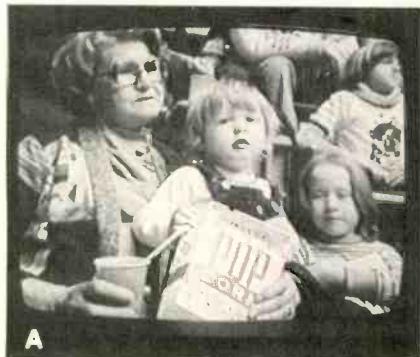
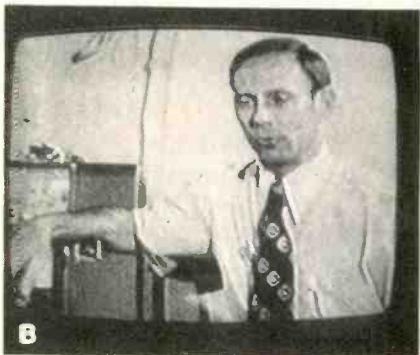
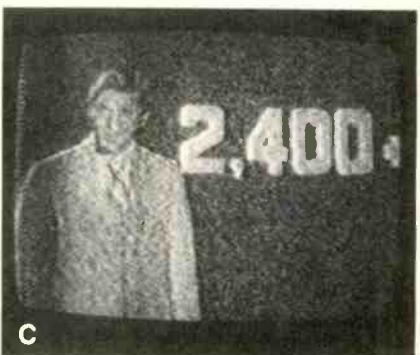
These pictures illustrate three signal-to-noise ratios. The top picture has no perceptible snow for a S/N of about 45 dB. Some snow at about 29 dB is shown by the center picture, while an unacceptable 22 dB S/N is pictured at the bottom.

Most MATV systems are designed for adequate signal level at each TV tap-off. However, many of them have too much snow in the picture. On the other hand, any MATV system that has excellent signal-to-noise ratio will automatically have sufficient signal level to each TV. Use these suggestions to minimize snow in the systems you design or repair.

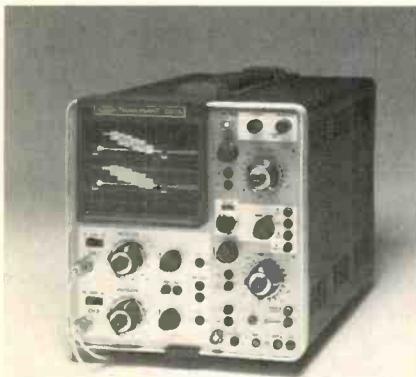
Dual-trace delayed-sweep scope

One unique feature of the model D67A **Telequipment** scope is "mixed" sweep, with one sweep rate scanning the picture over part of the screen and another sweep rate working across the rest of the screen. This delayed sweep can be adjusted according to need. Dual-trace operation permits viewing of two waveforms simultaneously by either alternate or chopped mode. Conventional horizontal sweep times can be selected between 40 ns and 2 s per graticule division. A sync separator is built-in to provide stable TV vertical and horizontal displays.

Maximum sensitivity of each vertical channel is 10 mV, and minimum sensitivity is 50 V per division. Bandwidth is from dc to above 15 MHz.

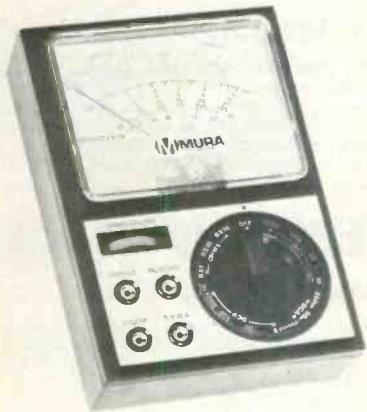
Portable VOM

Meter protection and a mirrored scale are two features of the **Mura** model NH-63 VOM multimeter. Sensitivity of the six dc ranges is 20,000 ohms-per-volt, and it is 10,000 Ω/V for the four ac ranges. In addition,

three resistance ranges and two dc current ranges are provided.
