TECHNICAL INFORMATION

TYPE NO <p style="text-align: center;">FB/IN/ES 5100</p>	TYPE <p style="text-align: center;">FB/IN/ES</p>	T.I.-NO <p style="text-align: center;">... 06/01</p>				
SERIAL NUMBERS AFFECTED From machine number 500513		ISSUED BY Documentation/ Wittenborg Odense				
SUBJECT <p style="text-align: center;">Vending machine controller 47107602</p>		ISSUED FOR (X): <table border="1" style="width: 100%; border-collapse: collapse;"> <tr> <td style="padding: 2px;">Action</td> <td style="width: 20px;"></td> </tr> <tr> <td style="padding: 2px;">Information</td> <td style="text-align: center;"><input checked="" type="checkbox"/></td> </tr> </table>	Action		Information	<input checked="" type="checkbox"/>
Action						
Information	<input checked="" type="checkbox"/>

New part No: 47107602 ver. 1.1 Vending machine controller

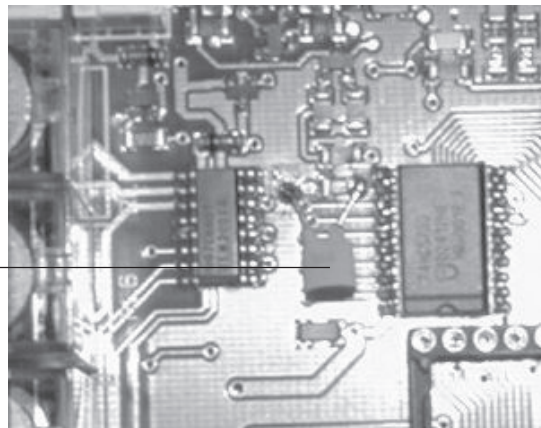
Noise capacitor

- From the above machine number a noise capacitor 100pF will be mounted on the above mentioned vending machine controller.

- In some machines it could happen that the SPC did not respond on a selection. Noise from the fan motor relay could disturb the electronics.
After having mounted the noise capacitor 100pF the problem has been solved.
