Section 4: CBA-2 Maintenance

SYSTEM DESCRIPTION

The Rowe Compact Bill Acceptor-2 (CBA-2) extends the capability of your equipment to include the acceptance of one and five dollar bills. Valid bills of genuine United States currency are accepted by the CBA-2, which then outputs credit pulses. Rejected bills are returned to the customer.

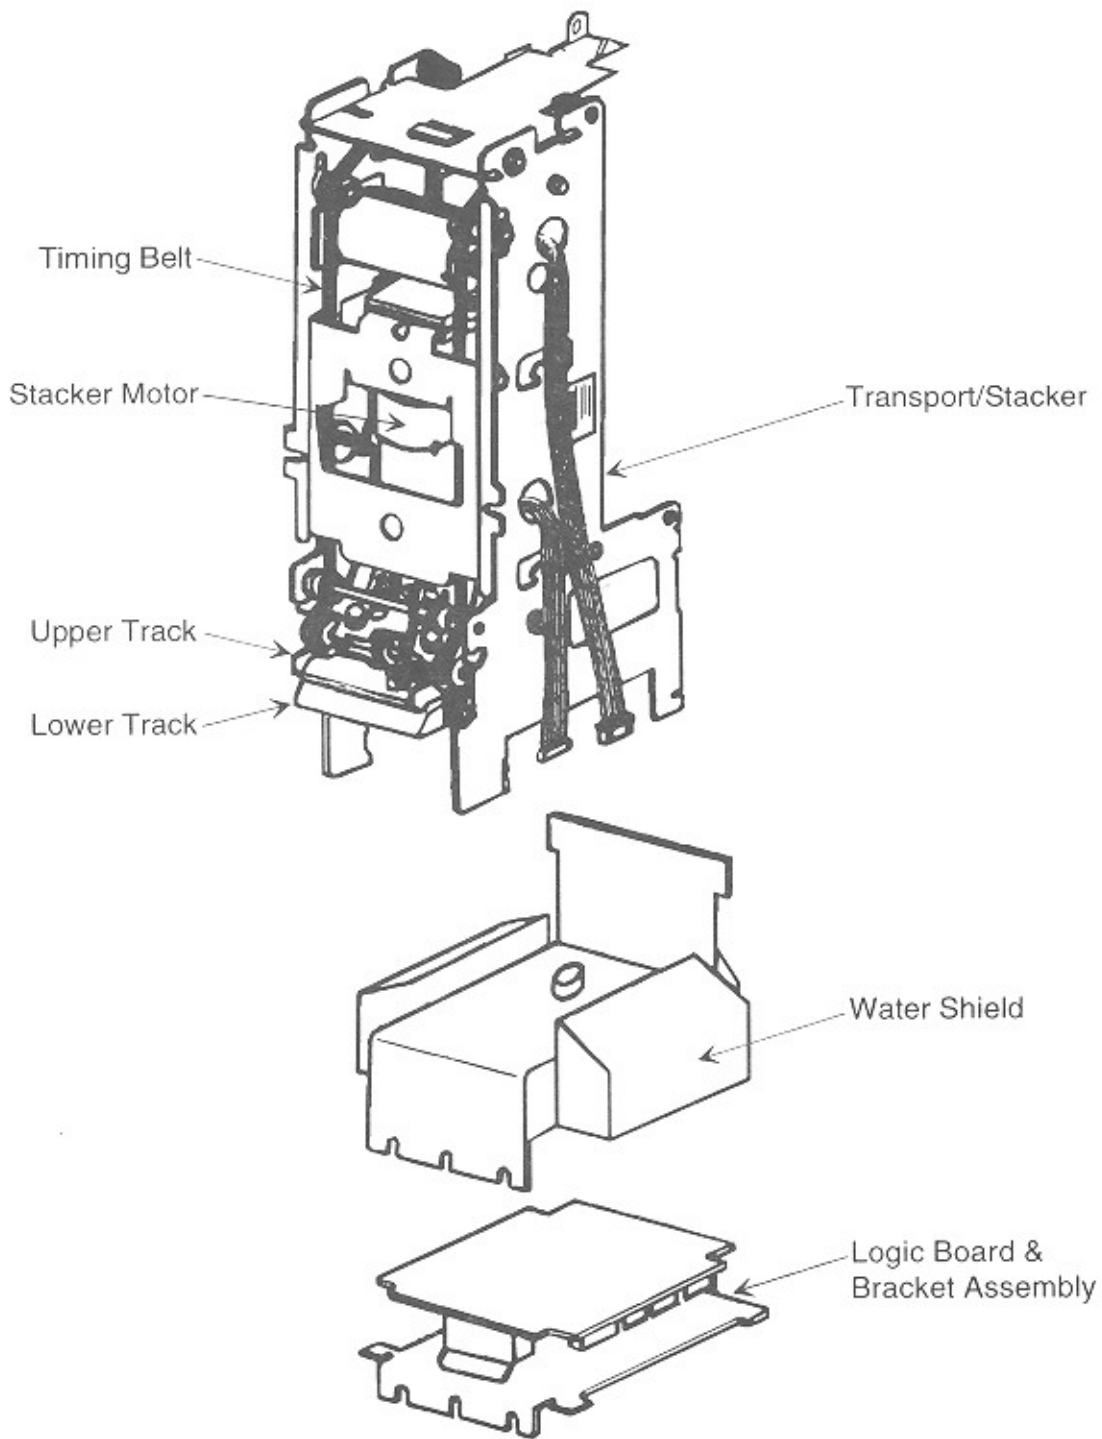
Figure 4-1. CBA-2 Components

The CBA-2 consists of a bill acceptor transport/stacker mechanism, an electronic logic board, and a power supply integrated into a single unit.

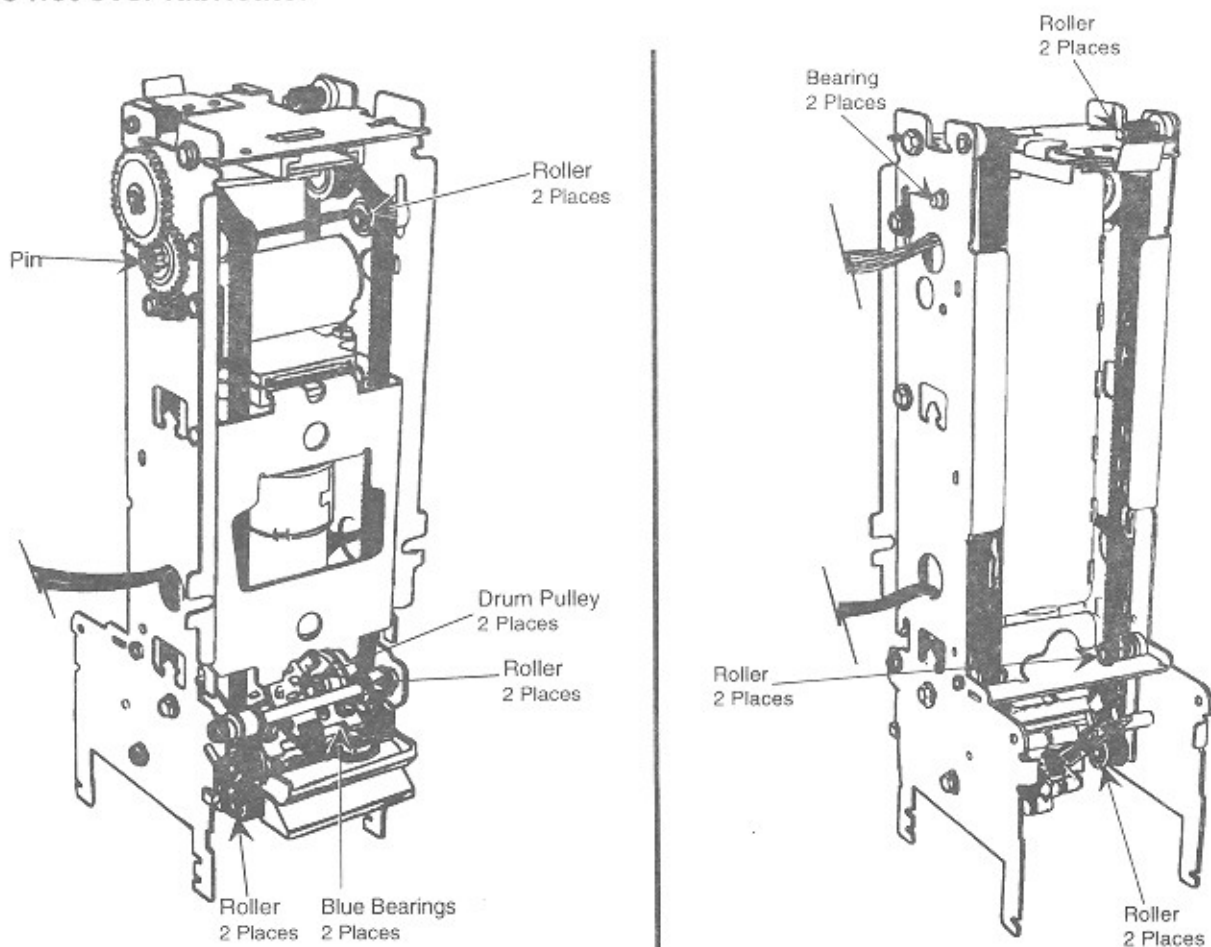
Figure 4-4. Oiling Locations

See *Figure 4-4* for oiling locations.

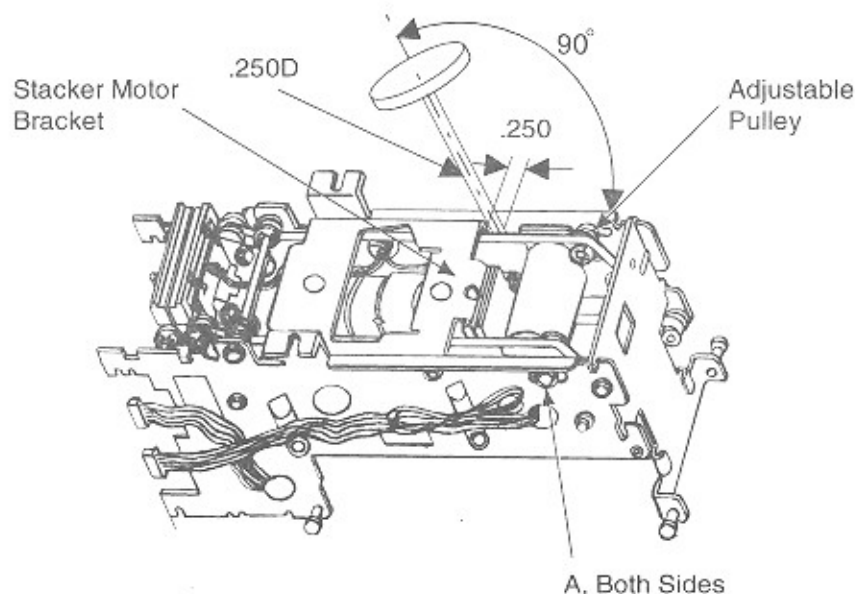
Figure 4-5. Timing Belt Tension Adjustment

1. Apply a force of 118 grams to each belt. Each belt must deflect a distance of 3/16 inch.
2. Apply the force mentioned in step 1 with the end of a 1/4 inch diameter pin. The centerline of the pin must be centered on a line that is 1/4 inch from the stacker motor bracket and the pin must be centered on the belt. Apply the force in a direction perpendicular to the belt.
3. If the tension is not correctly set, loosen the screw(s) (A) in *Figure 4-5* so that the pulleys move freely in their slots. Adjust the pulley(s), tighten the screw(s), and recheck the belt deflection.

Refer to *Figure 4-5* for adjustment locations and the precision adjustment illustration.

If this general adjustment procedure is not satisfactory, you may use the following precision adjustment procedure (*Refer to Figure 4-5*):

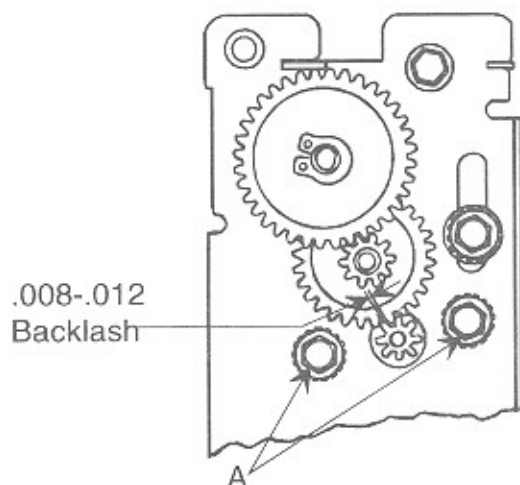
Figure 4-6. Gear Backlash Adjustment

Check that the gears in *Figure 4-6* have a slight backlash of .008 to .012 inch. To adjust the gear backlash:

1. Loosen the two Hex-head adjusting screws (A) holding the motor.
2. Move the motor to obtain the correct backlash.
3. Tighten the two screws and recheck the gear backlash.

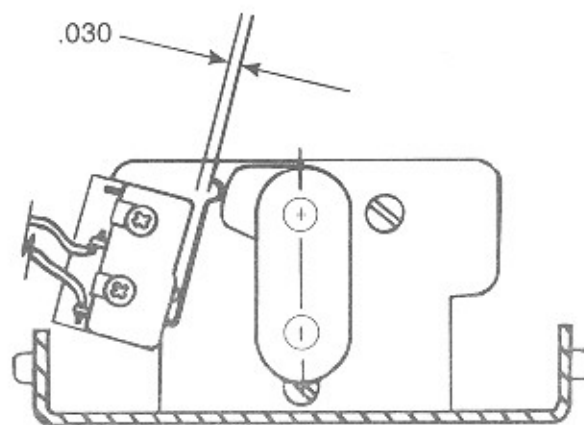
Figure 4-7. Stacker Home Switch Adjustment

Check for a gap of $1/32$ (.030 inch feeler gauge) between the stacker switch arm and the stacker switch body as shown in *Figure 4-7*.

1. Loosen the two adjusting screws as shown in *Figure 4-7*.
2. Position the cam so that the switch arm rests on the raised lobe of the cam.
3. Insert a $1/32$ inch gauge (0.030 inch feeler gauge) between the switch arm and the switch body.
4. Hold the switch against the arm and tighten the two adjusting screws.

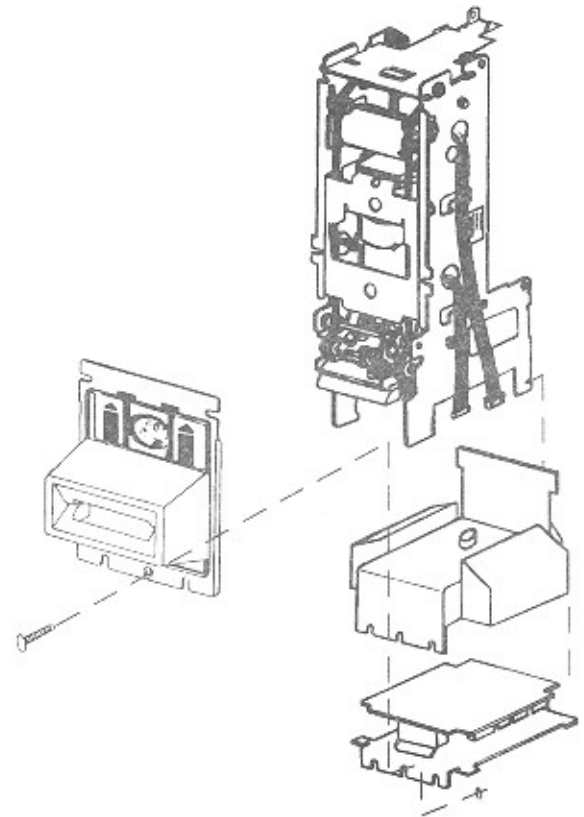
Figure 4-8. Removing the Bill Inlet

1. Remove the countersunk screw that holds the inlet on the front of the transport (See *Figure 4-8*).
2. Lift off the inlet.

1. Slide the water shield into its former position.
2. Re-install the logic board, reconnect the wiring harnesses, and re-install the inlet (See *Figure 4-8*).

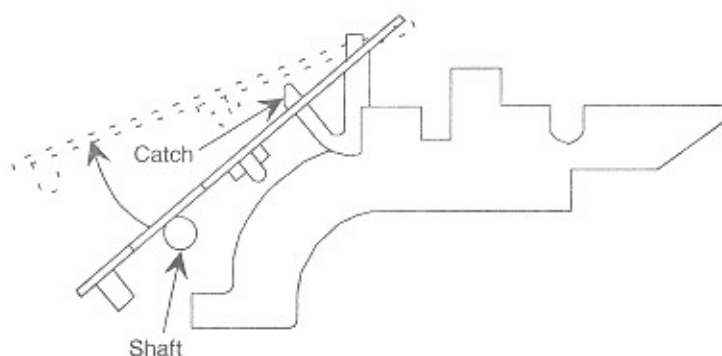
Figure 4-9. Removing the Cell Assembly

1. Remove the water shield (see *Removing the Water Shield* in the preceding paragraph for this procedure).
2. Unhook the circuit board by pushing back on the catch (see *Figure 4-9*), then remove the board.

CAUTION:
The plastic circuit board catch, shown in *Figure 4-9*, can be damaged very easily if it is allowed to push its way through the circuit board. Always pull the catch tip to the right so that the catch will pass through the circuit board without damaging the catch tip.

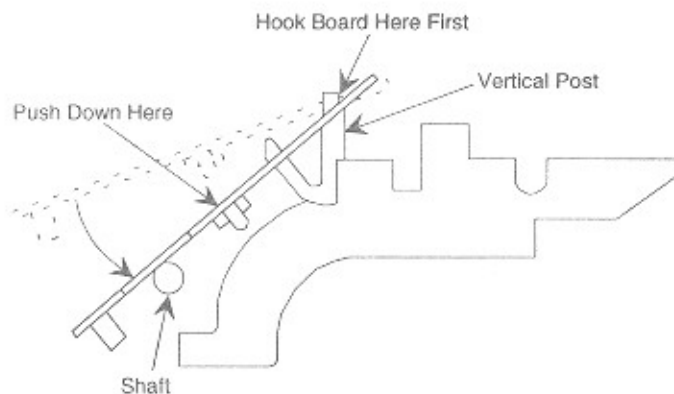
Figure 4-10A. Mounting the Cell Assembly

1. To replace the assembly on the lower track, set the transport upside down. Hook the board over the vertical post, pull the catch back, then push down on the board to snap it under the catch (See Figure 4-10A).
2. Re-Install the water shield (See *Re-installing the Water Shield* in this section).
3. Check to see that the catch is hooked over the board (A) and the board is setting in the recessed area on the shaft (B). See Figure 4-10B.
