SECTION 4-OBA-P MAINTENANCE

This section provides general and detailed service information for the Rowe OBA-P Bill Acceptor, including a physical description, functional description, routine maintenance, and unscheduled maintenance.

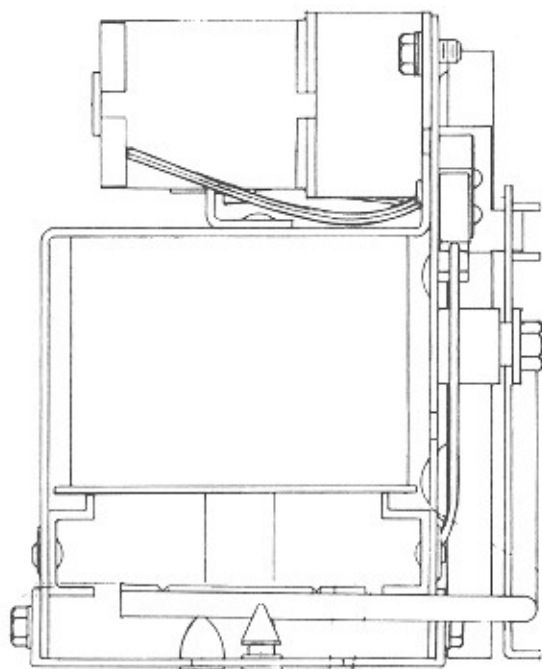
Figure 4-1. Pusher Plate Adjustment

1. Rotate the cam so that the switch actuator rests on the high point of the Stacker Motor Cam.
2. Place a .040 to .050-inch gauge between the cam and the actuator. The bottom of the actuator should rest against the switch case. If the adjustment is incorrect, reposition the switch by loosening its two mounting screws.
3. Align the pusher plate to the guide rails by loosening the three motor bracket screws and moving the motor assembly. The pusher plate and the guide must be positioned within 1/64 inch as shown in Figure 4-1.).

The Bill Stacker does not normally require adjustment. If the Computer Control Unit indicates a problem involving the Home switch while in shutdown mode (See **Troubleshooting.**), then the switch adjustment may be checked by performing the following procedures:

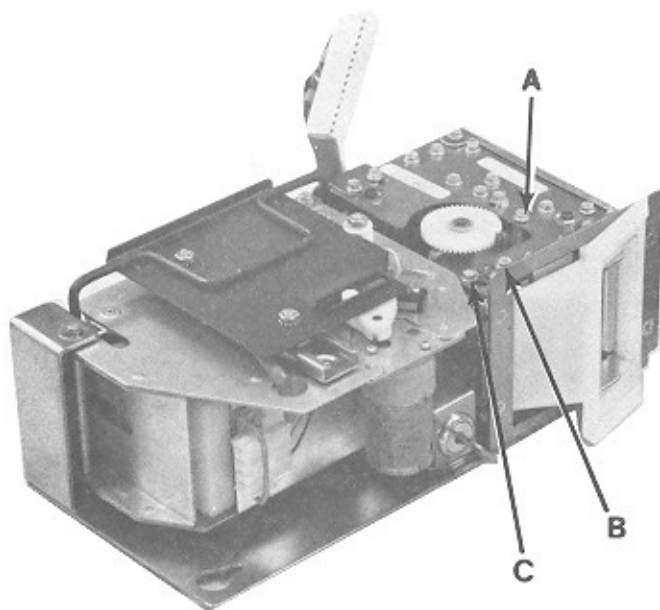
Figure 4-2. Drive Belt Tension

Adjust the drive belt on units with Pivoting Motor Bracket as follows: (See Figure)

1. Loosen the three hex head-screws labelled A, B and C.
2. Pivot the Motor Assembly on Screw A until the Drive Belt has a total flex of approximately 3/32 inch between the Gear Pulley and the Drive Shaft Pulley.
3. Tighten Screw A and then B and C.
4. Check the belt tension. If the Drive Belt will not hold tension properly because the motor assembly will not pivot, the belt has become stretched and should be returned to an authorized service center for repair.

Drive Belt Tension (See Figure 4-2.)

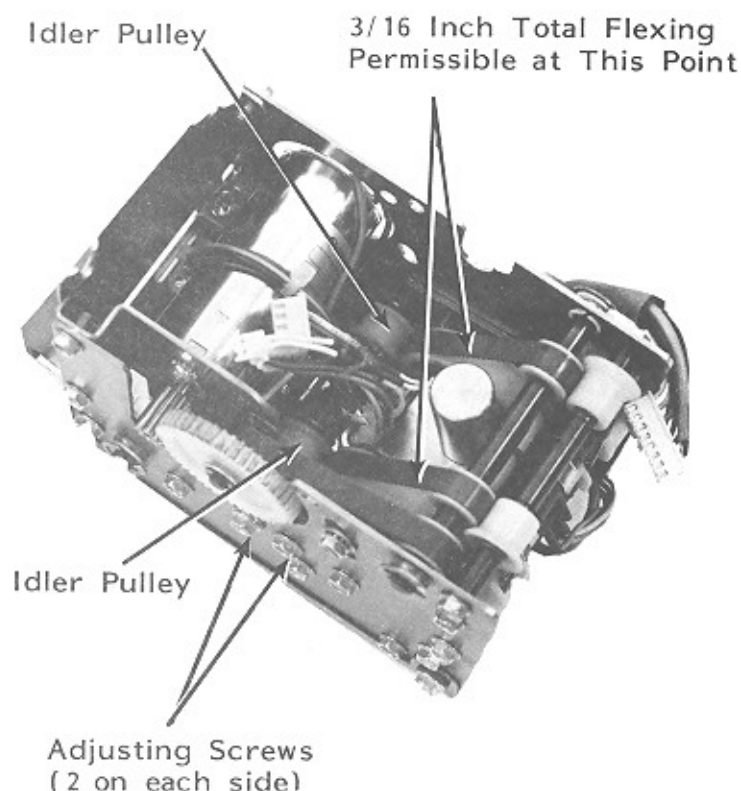
Figure 4-3. Lower Belt Adjustment

Adjust the Lower Belt tension as follows: (See Figure 4-3.)

1. Loosen the four hex-head screws holding the ends of the Idler Pulley Shaft and the take-up brackets (Shown in Figure 4-3.).

2. Remove the circuit board by removing the three screws that hold the brackets and unplug the three connectors.
3. Push down on the idler pulleys until the belt flexes about $\frac{3}{16}$ of an inch.
4. Tighten all four screws and check the belt tension again. The tension must be equal on both belts.
5. Replace the circuit board and plug in the three connectors.
6. If the adjusting screws are against the ends of the slots and the timing belts are still loose, the transport should be returned to an authorized service center.

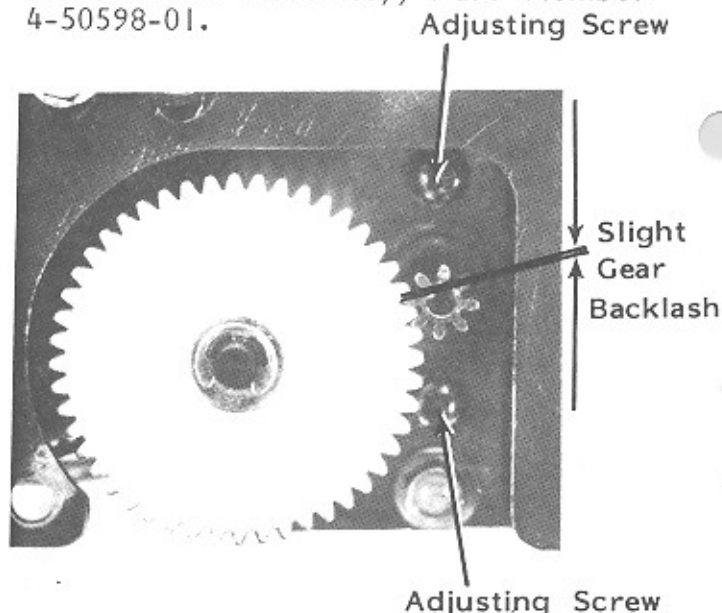
Figure 4-4. Gear Backlash Adjustment

A degree of backlash should exist between the gears, as shown in Figure 4-4. To adjust the gear backlash:

1. Loosen the two Phillips-Head screws holding the motor. Move the motor to give the correct backlash. This adjustment is not critical, but make sure that backlash is present at all points, as you rotate the gears.
2. Tighten the two screws and recheck the gear backlash.

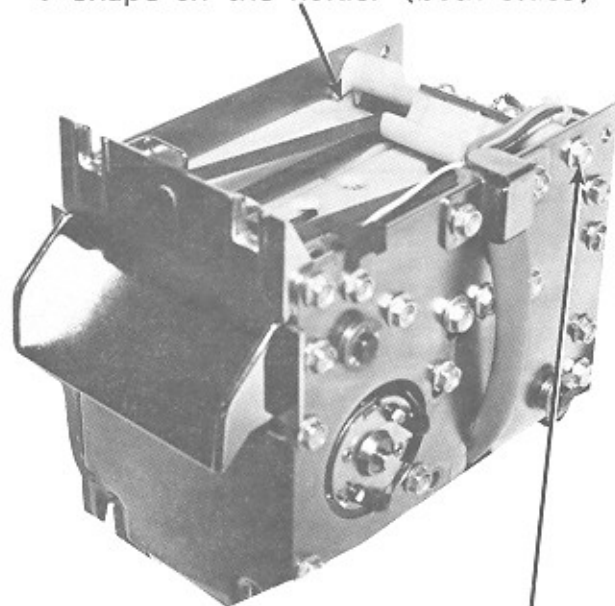
Figure 4-5. Magnetic Head Alignment

1. Install the four screws loosely, and align the assembly with the lower track by pressing the V on the holder firmly against the V on the lower track (as shown in Figure 4-5.).

The V shape on the Lower Track must be firmly aligned with the V shape on the holder (both sides)

Tighten This Screw First (One Each Side)

The Magnetic Head is aligned with the Harness and Holder assembly at the factory. If a problem with the head develops, the Harness and Holder assembly must be replaced. Order the Harness and Holder Assembly, Part Number 4-50598-01.
