**TV REPAIR**

**QUESTIONS**  
*and*  
**ANSWERS**  
*on*  
**DEFLECTION & H-V CIRCUITS**

by **SIDNEY PLATT**

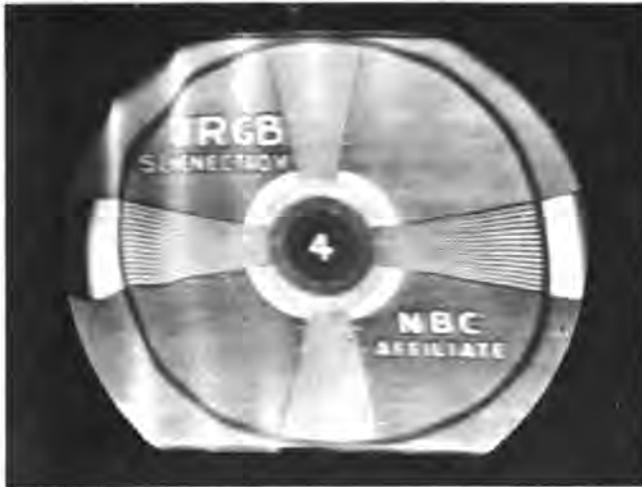
Fig. 1-6. Picture showing cross-talk of the horizontal-sweep frequency components into the vertical-deflection coils. Courtesy General Electric Co.

b. Crosstalk between coils in the yoke is indicated if a waviness is observed as light and dark vertical bars (Fig. 1-6). (The condi-

tion shown in Fig. 1-6 represents an extreme condition that would rarely be seen in practice.) Check the balancing capacitor connected across one-half of the horizontal deflection coil, and replace it if necessary.

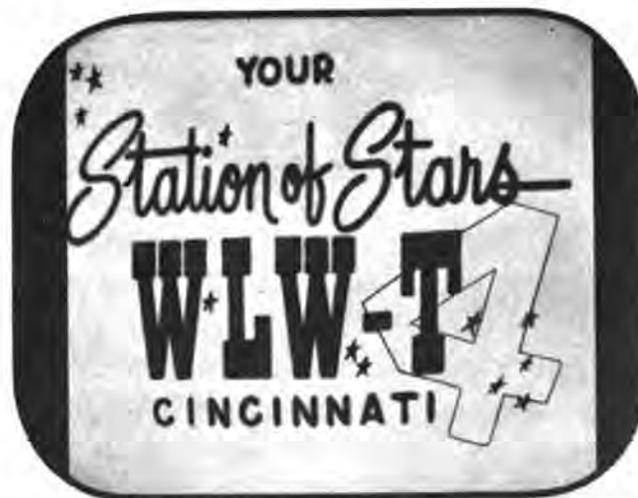
**Fig. 1-7.** Lack of adequate width in picture. Courtesy Crosley Corp.

**QUES. 1-7.** What are some of the receiver controls and adjustments that, when improperly adjusted, produce a narrow picture (Fig. 1-7)?

**QUES. 1-9.** After a short period of normal operation, the width of the picture decreases until a sizable border appears on either side of the picture tube (Fig. 1-7). The horizontal deflection and damper tubes are checked and found to be good. Although the sweep voltages measure somewhat below normal, no defective component can be located. What is a possible cause of trouble?

**QUES. 1-11.** The receiver picture lacks normal width (Fig. 1-7). All tubes are checked and found to be good, as are all adjustments. Voltage and resistance measurements are made, and are found to be normal. How as a last resort may the picture width be increased?

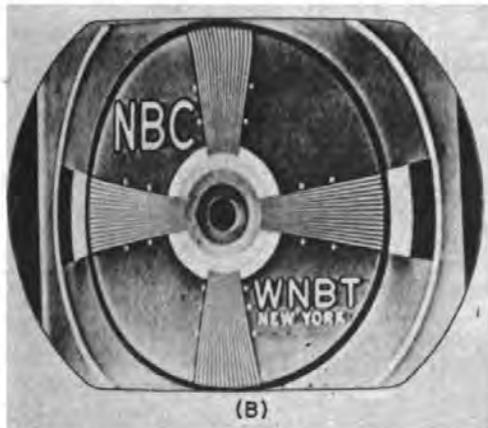
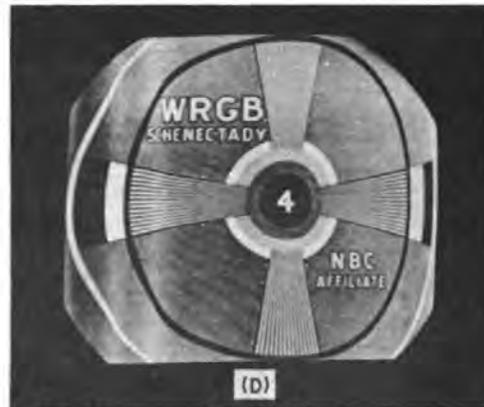
Fig. 2-1. (A) Typical horizontal-output section of a tv receiver. After Admiral Corp. (B) Reduced width, compressed left side. Courtesy RCA Service Co. (C) Reduced width, foldover at right. (D) Reduced width, compressed right side. Courtesy General Electric Co.

**QUES. 2-1.** What are some of the effects of faulty components in the typical horizontal output circuit illustrated in Fig. 2-1(A)?

**ANS.** The picture symptoms produced by defective components in a receiver similar to that shown in Fig. 2-1(A) are listed in Table 2-1.

| Component | Function | Defect | Symptom |
|---|---|---|---|
| <i>R437</i> | Grid return | Increased value | Reduced width, compressed left side (Fig. 2-1B). |
| | | Decreased value | Reduced width, foldover at right (Fig. 2-1C). |
| <i>R440</i> | Cathode bias | Increased value | Reduced width, compressed right side (Fig. 2-1D). |

**DISCUSSION.** In many cases, careful analysis of the picture symptoms will aid in quick location of the faulty component. In this section of the receiver, as in other sections, voltage and resistance checks and replacement tests are the primary methods for locating the actual defective component.

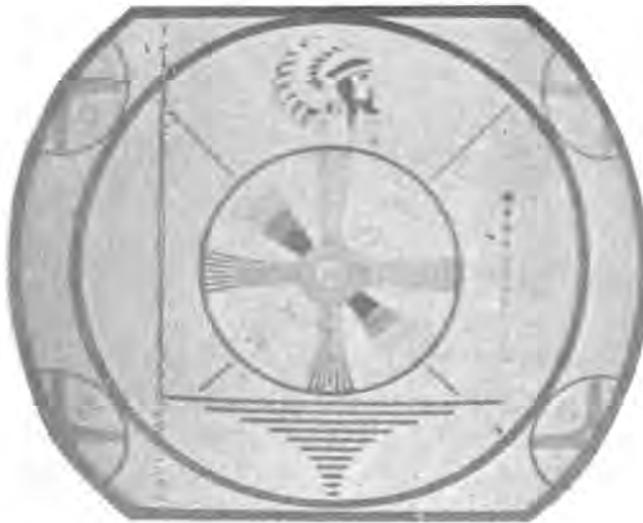
**Fig. 2-3. Barkhausen oscillations. Courtesy General Electric Co.**

**QUES. 2-3.** Several black vertical lines appear at the left side of the picture (Fig. 2-3), and are very noticeable during the reception of weak signals. What is the cause of these lines?

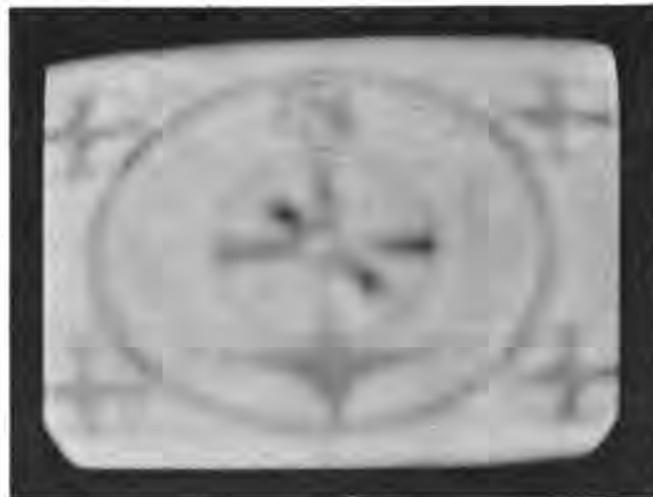
**Fig. 3-18.** Picture blooming.

**QUES. 3-18.** Picture brightness is generally low. The picture blooms and loses brightness (Fig. 3-18) as the brightness control is advanced to the position that normally corresponds to maximum brightness. What is the probable cause of trouble?

**DISCUSSION.** As a rule, picture blooming is caused by poor high-voltage regulation. Thus, as the brightness control is advanced, the resultant increase in second anode current causes the high voltage to decrease, and blooming occurs.

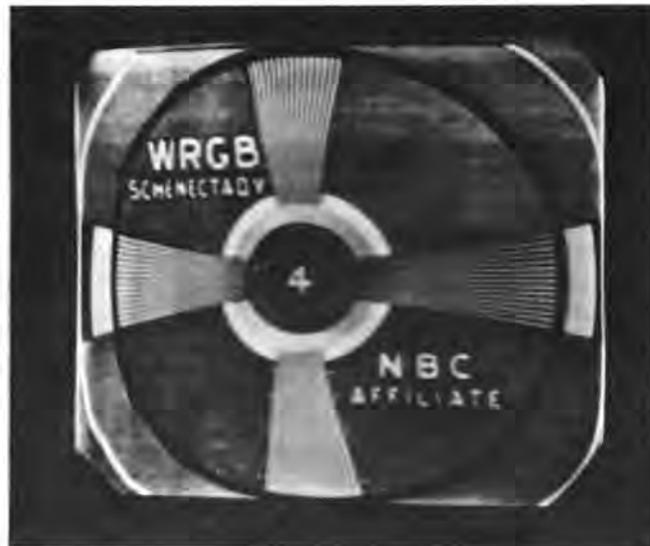
**QUES. 4-7.** The horizontal linearity is poor, with the right section of the picture stretched excessively (Fig. 4-7). The horizontal deflection and damper tubes are checked and found to be good. Adjusting the horizontal linearity coil so that the slug is completely within the winding reduces the stretch a great deal, but does not eliminate the trouble completely. What is the probable cause?

**Fig. 4-7.** Poor horizontal linearity, with right side of picture stretched excessively. Courtesy General Electric Co.

**ANS.** One of the boost capacitors is of incorrect value. Test the capacitors by replacing with ones of properly rated values.

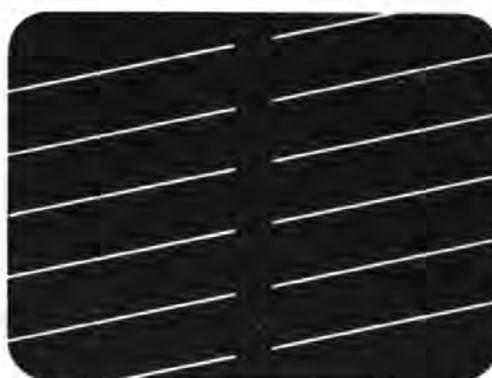
Fig. 7-6. Proper slant of vertical-retrace lines.

visible. If the horizontal connections are correct, the vertical retrace lines should be diagonal lines that run from the lower left portion of the picture to the upper right section, as shown in Fig. 7-6.

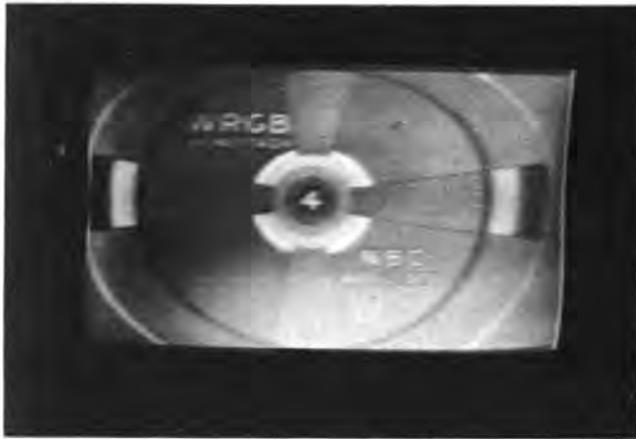
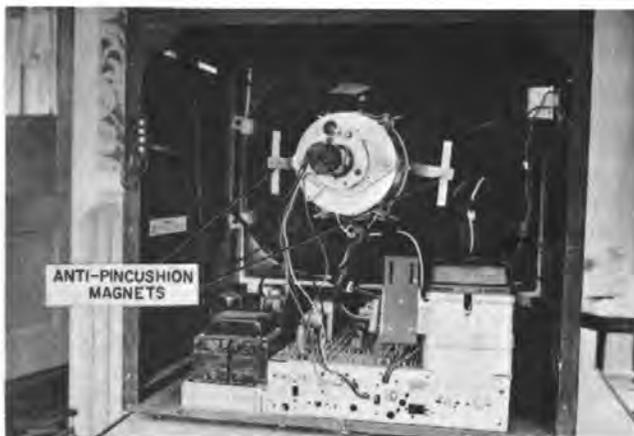
**ANS.** The use of a cosine-wound yoke in place of an ordinary yoke may produce a noticeable pincushion on the raster (bowing in along the edges of the raster, Fig. 7-7A). Use corrector magnets to compensate for, and to eliminate the pincushion effect.

**Fig. 7-7.** (A) Pincushion effect, with height and width reduced to make effect more noticeable. (B) Location of anti-pincushioning magnets. *Courtesy General Electric Co.*

In many receivers that use cosine yokes, two anti-pincushioning magnets are mounted on the picture tube mounting brackets (Fig. 7-7B). These magnets are inserted so that they may be moved forward or backward to permit proper adjustment. The adjustment of the magnets is made by moving the raster so that first one edge and then the other is seen.

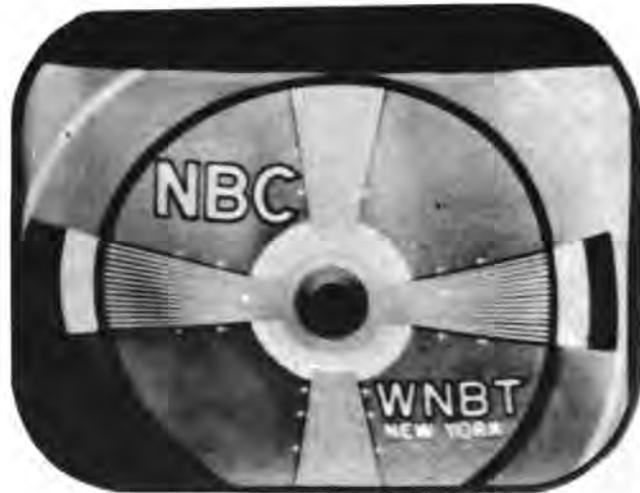
Fig. 7-10. Picture showing neck shadow. Courtesy RCA Service Co.

**QUES. 7-10.** After placing a receiver chassis, including deflection yoke and focus coil in the tv cabinet (the picture tube is cabinet-mounted), it is noted that neck shadow (Fig. 7-10) is present on the picture. What is the probable cause of trouble?

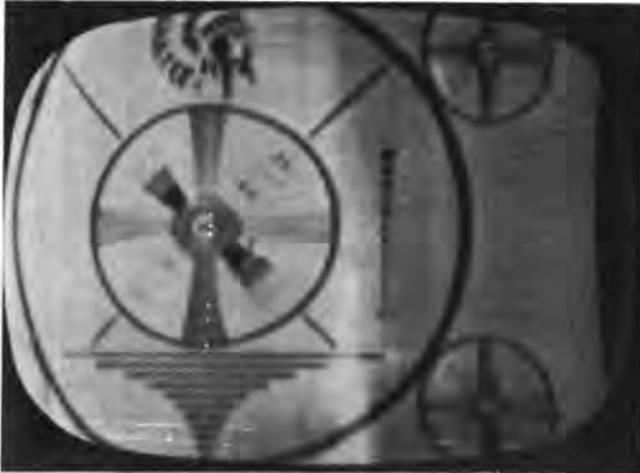
Fig. 7-17. Horizontal foldover.

**QUES. 7-17.** Instead of a full raster, a thin, white horizontal line is observed on the picture tube. After checking the vertical circuit, a defective deflection yoke is found and is replaced. When the receiver is turned on after the yoke replacement, horizontal foldover (Fig. 7-17) is seen on the screen. What is the probable cause of trouble?
